By appointment to
Her Majesty The Queen
Building Façade Restoration
and Conservation

71 Lombard Street

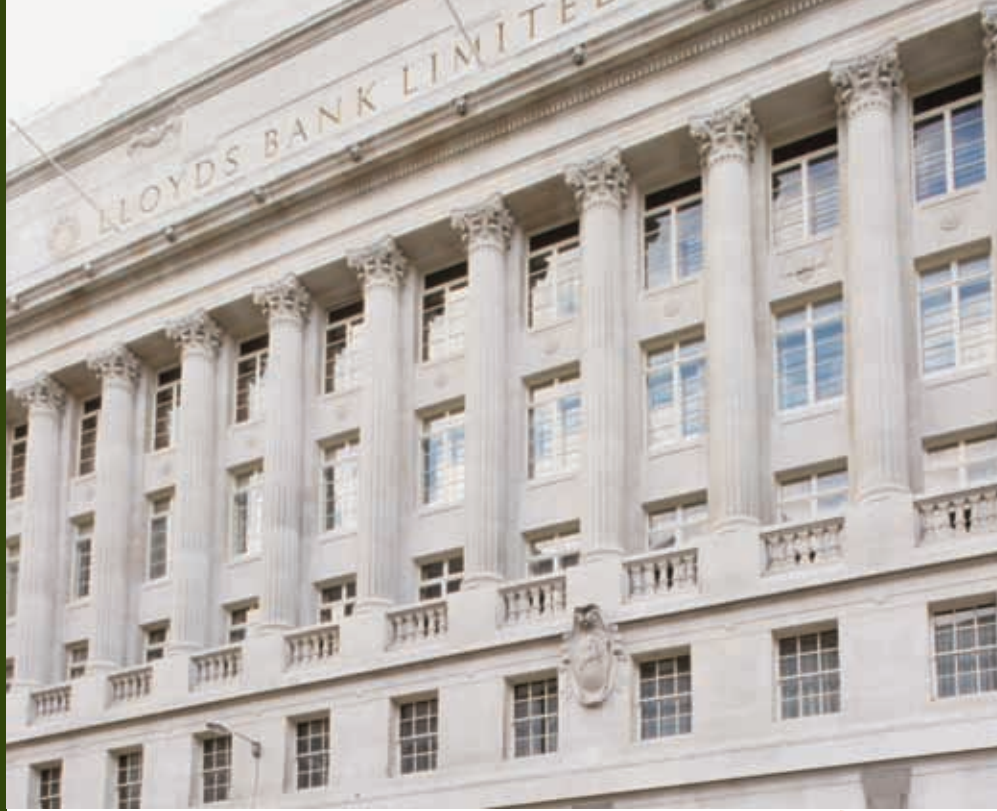
The Lombard Street Grade 2 listed building, designed by Thomas Tait and constructed between 1927 and 1929, incorporated a steel frame over which Portland Stone cladding had been erected. Corrosion within the steel beams caused fracturing and displacement of the stone masonry. The Department of the Environment has estimated that hundreds of steel-framed buildings built between 1908 and 1939 could be suffering from similar corrosion problems, generating potential repair bills in excess of £300 million.

PAYE masons have carefully cut out and matched all the defective Portland Stone on both the Lombard Street and Cornhill elevations. Before replacing the damaged sections of ashlar façade, the company's repair experts had to halt the corrosion to the old steel framework which they exposed by preparing and applying modern anti-corrosion compounds. In addition, Paye has installed cathodic protection to parts of the outer façade judged to be at most risk. This computer controlled system passes low voltage currents throughout the stonework to create a corrosion retarding electronic field around the steel framed members at risk.
