## Maiden Lane Canal Bridge

As part of a project to reconstruct the Victorian Maiden Lane bridge over the Grand Union Canal in London experts from PAYE Stonework and Restoration rescued quoins, the bridge corner stones which have been scored with rope marks by the original barge traffic. These silent witnesses to a slower form of commercial transport were reused in the strengthened bridge.

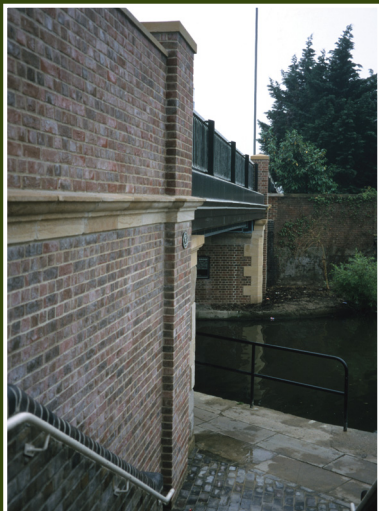
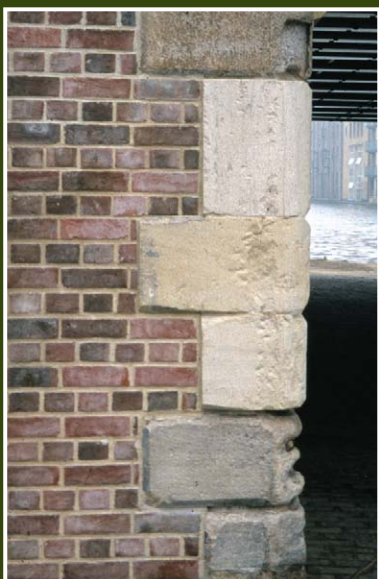
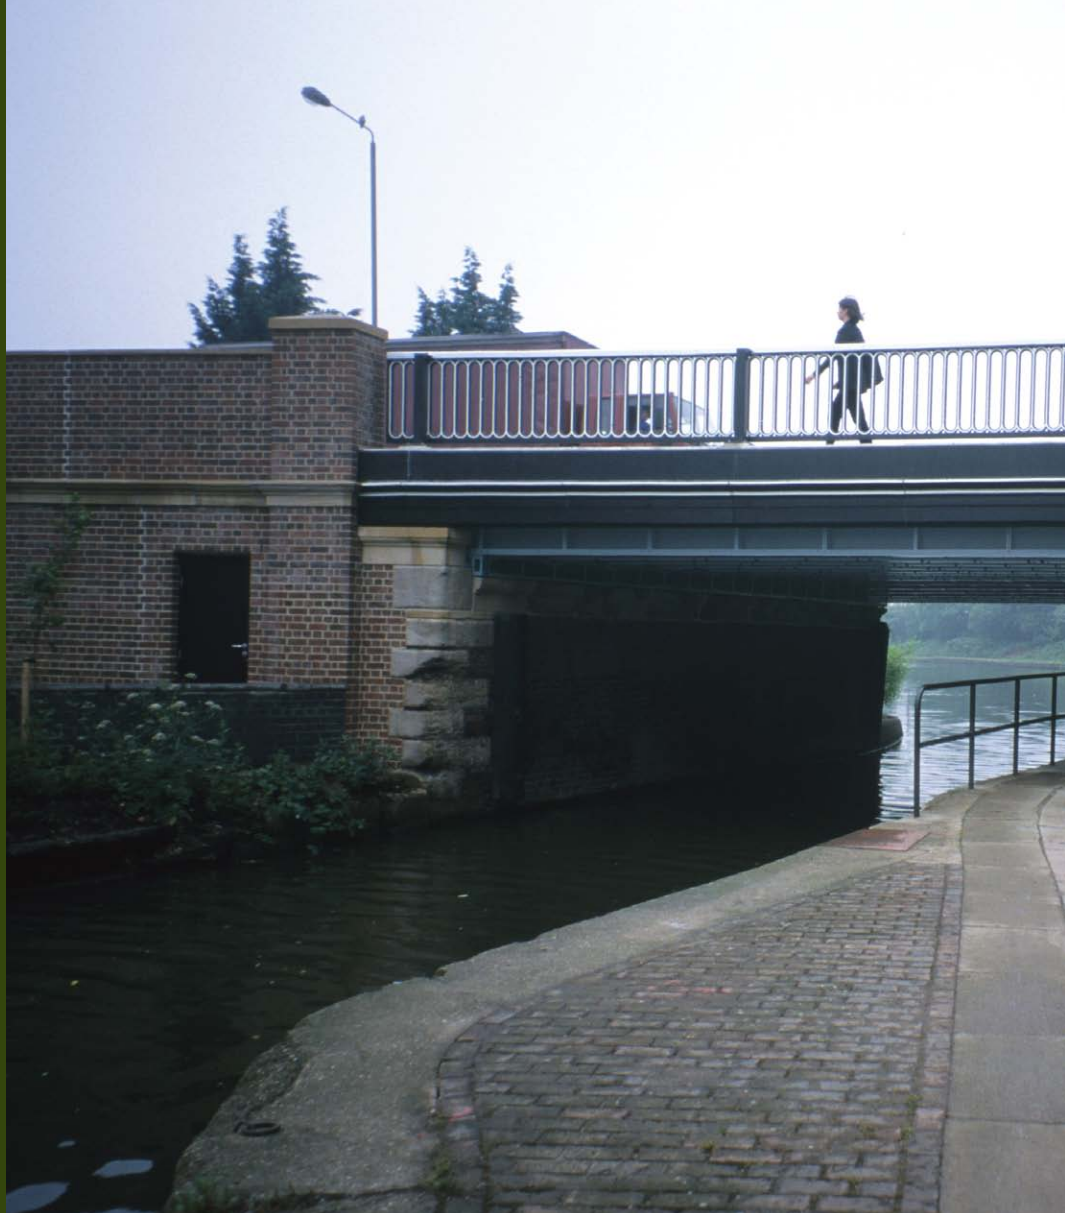
The bridge was widened with new decking on a prefabricated steel beams. The stone cornice which topped the brick parapets leading to the bridge was salvaged then cleaned and restored.

New stones for badly deteriorated sections of the bridge had to be matched and cut to fit. To assist the integration of the modern day stone, one complete corner of the bridge was re-built with new blocks, releasing original material for incorporation in the other corners.
