By appointment to
Her Majesty The Queen
Building Façade Restoration
and Conservation

Holy Trinity Maidstone

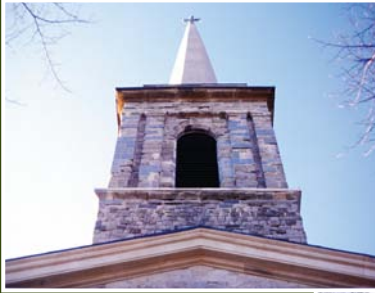
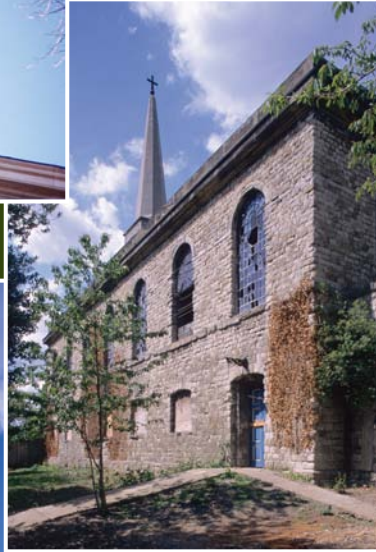
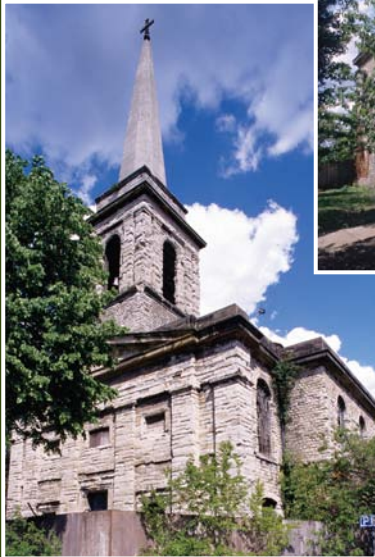
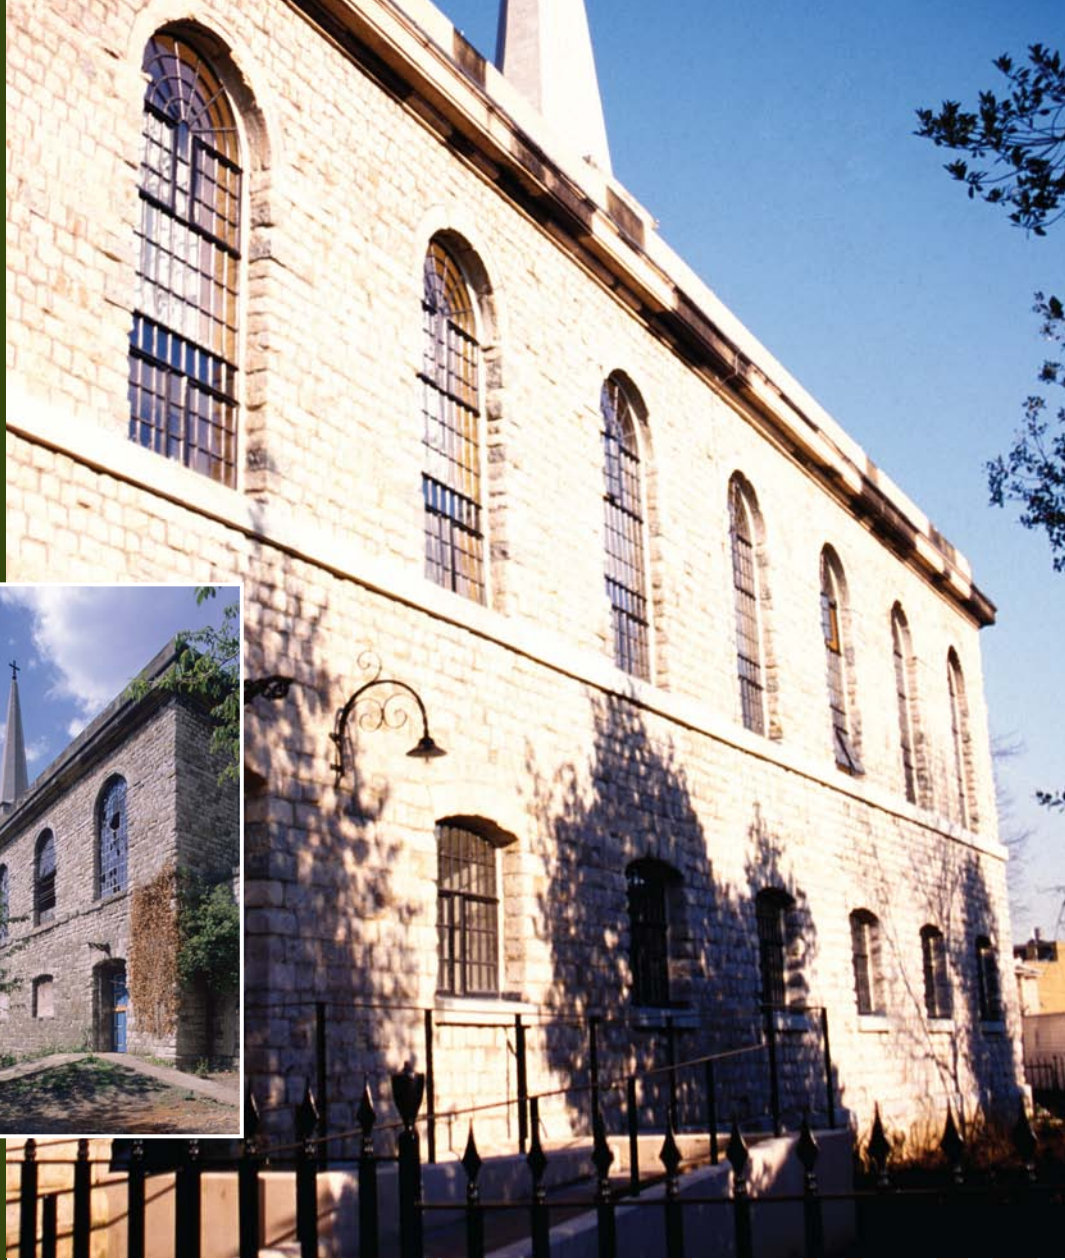
Redundant since 1974, the church had been seriously damaged by arson, fallen into disrepair, and had been heavily vandalised. The more exposed areas of the church such as quoins, cills, capitals and string courses suffered from weather damage and had to be replaced with newly carved stone. Kentish ragstone was a popular church building material in the 19th century but because it is very hard and variable, it is difficult to work .

Long neglected skills had to be resurrected by our stonemasons to repair the famous Maidstone Landmark, Holy Trinity Church. Our masons had to use 19th Century stone cutting techniques to replace weather damaged Kentish ragstone in the 1827 Grade II listed building.
