St Nicholas at Wade

St Nicholas at Wade church on the Isle of Thanet, dating back to the 12th century and containing exceptionally high quality medieval carvings echoing decorations in Canterbury Cathedral, represented some interesting challenges when we were called in to repair the south western tower.

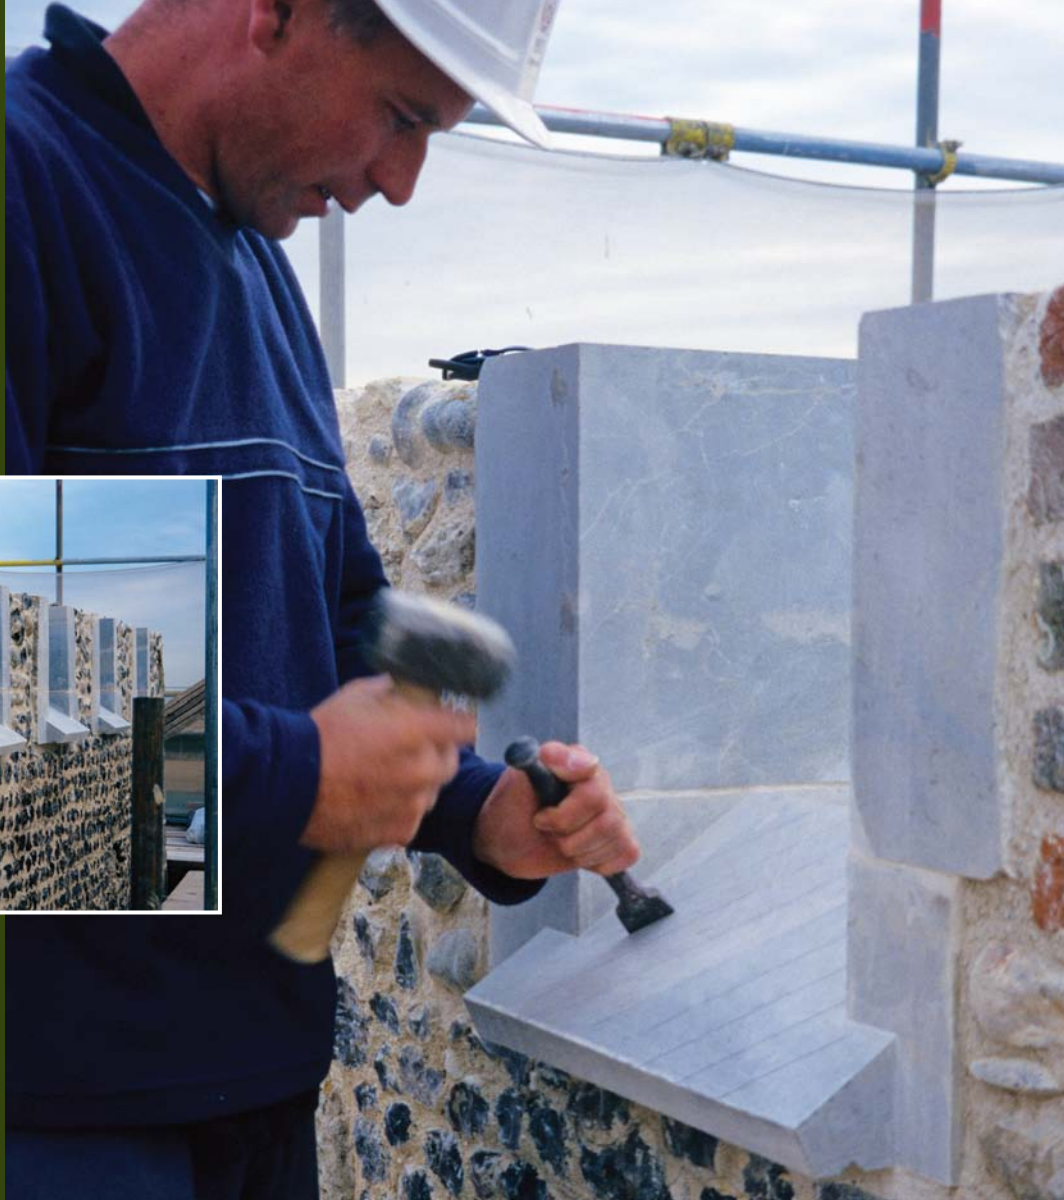
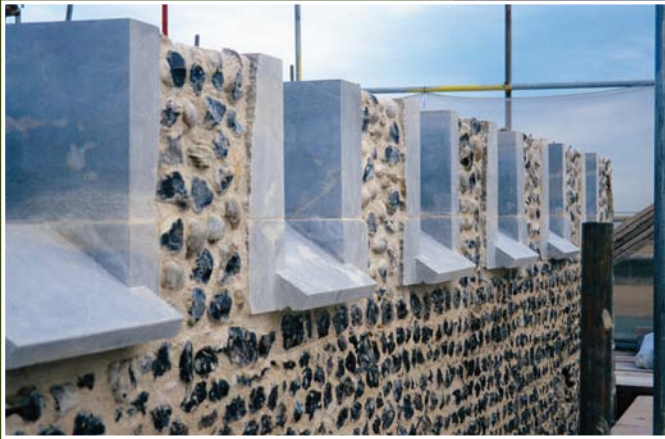
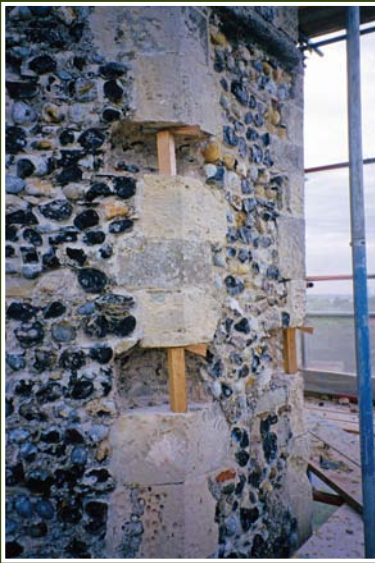
The upper two thirds of the 23m high tower had suffered from hundreds of years of coastal exposure. There were disintegrating copings, missing embrasure stones and some castellations starting to lean precariously.

Before repair could commence, the complex matrix of interlocking external stones had to be recorded and as the tower top was dismantled all the materials including the original rubble fill, were stored for re-use.

The medieval mortar that had held together the original wall was laboratory tested and exactly replicated, even down to the oyster shell fragments sourced from the nearby coastline, for rebuilding the flint and ragstone wall.
