By appointment to
Her Majesty The Queen
Building Façade Restoration
and Conservation

Public Records Office

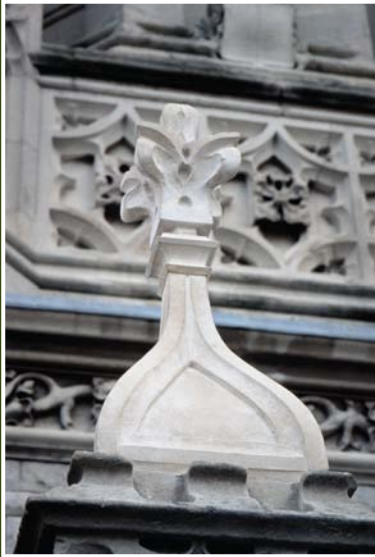
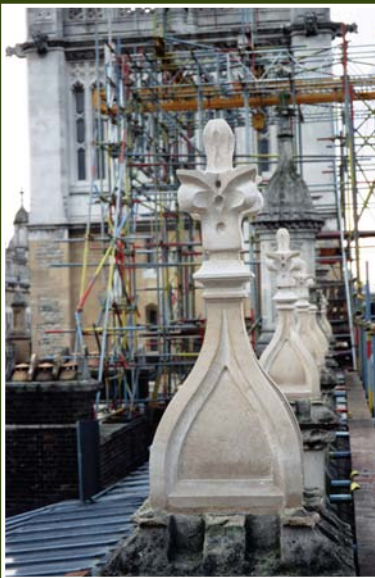
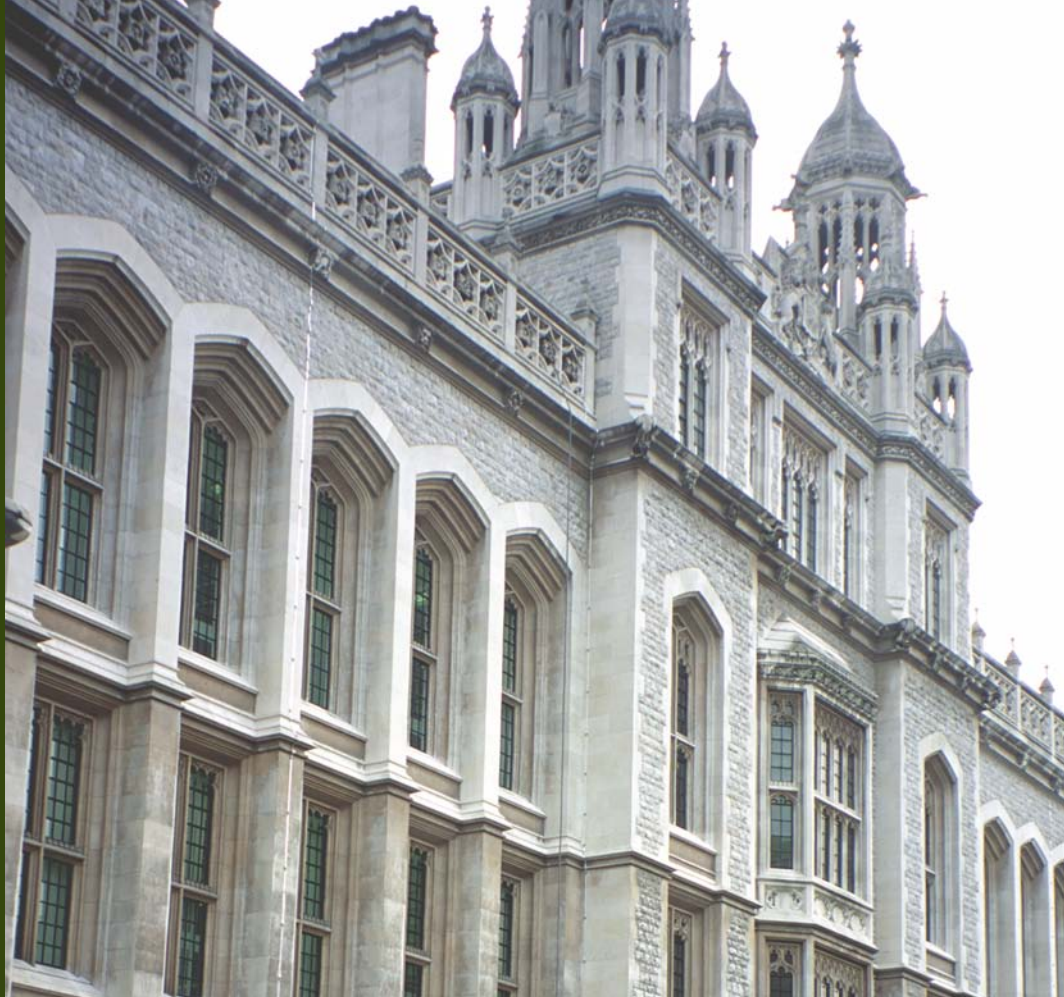
PAYE specialists were called in to repair and rescue, which in some cases was a complete re - make, the complicated carved Portland stone decorations embellishing the buildings clock tower.

The ornate pinnacle topping the clocktower was dismantled and replaced with a new copy. Portland stone, carefully chosen to replicate the original for colour, texture and quality produced a repair that was indistinguishable from the Victorian mason's work.

As well as the complex carved stonework replacements, company specialists have repaired much of the main buildings stonework and carried out extensive cleaning and repointing. Being one of England's most experienced repairers of Kentish rag stone, PAYE experts were able to replace and repair sections of the structure in which these materials had been used.
